Case History  
4.625" X 1.500"  
MXC-R

Short Bit & Tool Co.  
225 Gold St  
Garland, Texas 75042  
972-205-1011

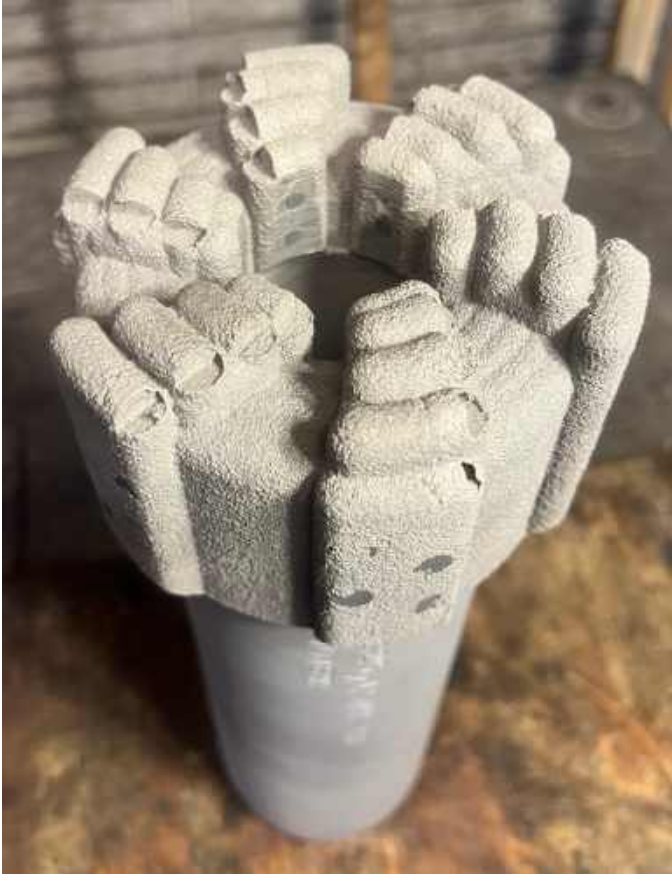
Client in NM with an ESP stuck with more than a week running numerous shoes, mills, grapples...**no hole made**

Our 4.625" X 1.500" MXC-R was custom fabricated overnight and ran 51.5 hrs reverse circulating to mill the loose junk on top of the target and 6 feet of the ESP which released and went to bottom.

The new mill at left has 24 - 3/8" WC carbide inserts in the leading edges of each Diamond Pod which is filled with 25% by volume of 30-40 mesh Diamond Grit (.018" to .020") to a depth of about 5/8" of useful diamond-impreg milling.

Client said, "We recovered a LOT more junk than the 6 feet of the ESP - the mill did its job"

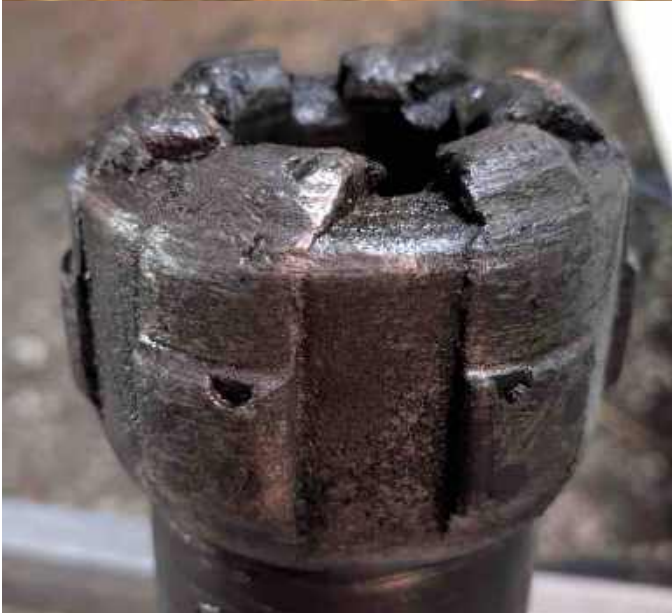
Days later the ESP was chased to bottom still with "a lot" of junk on top...tried mills and shoes with no results.

Ran a second 4 5/8" X 1 1/2" MXC-R and milled on junk couple of days then milled 4 more feet of the ESP...was able to latch on now the fish is on the bank.
