Case History  
4 5/8" SP-R  
Clean-Out Mill

Short Bit & Tool Co.  
225 Gold St  
Garland, Texas 75042  
972-205-1011

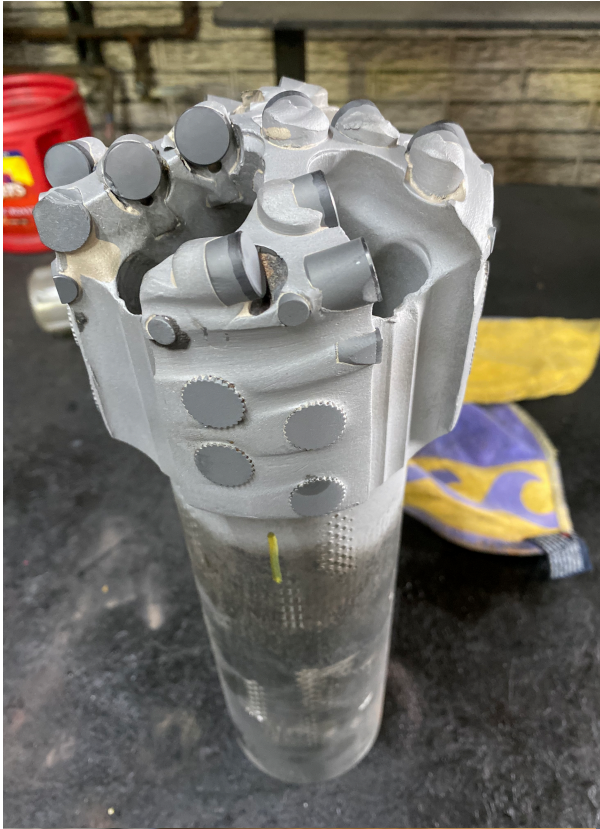
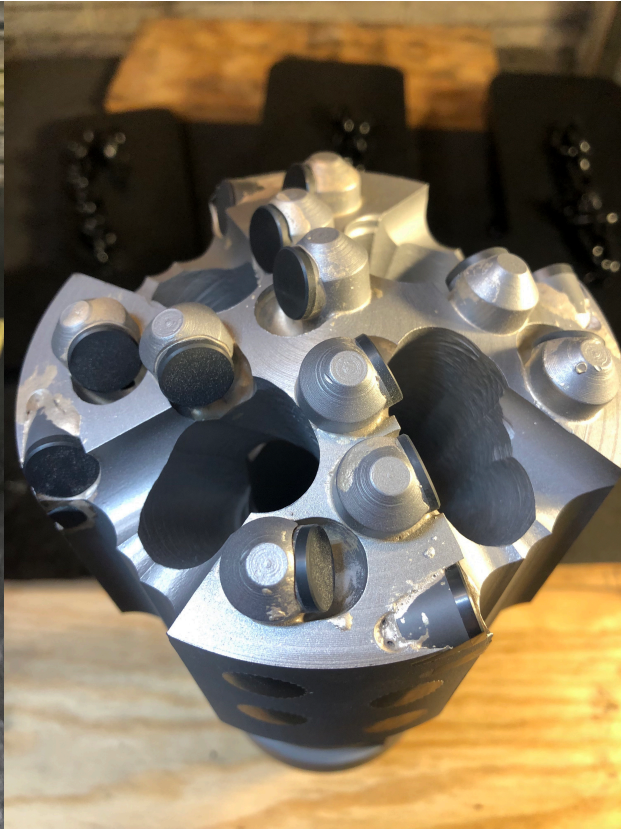
Stick Pipe reverse circulation 8,120 ft  
of abrasive fill and scale in 53 hours.  
In gage and refit with two new  
cutters.

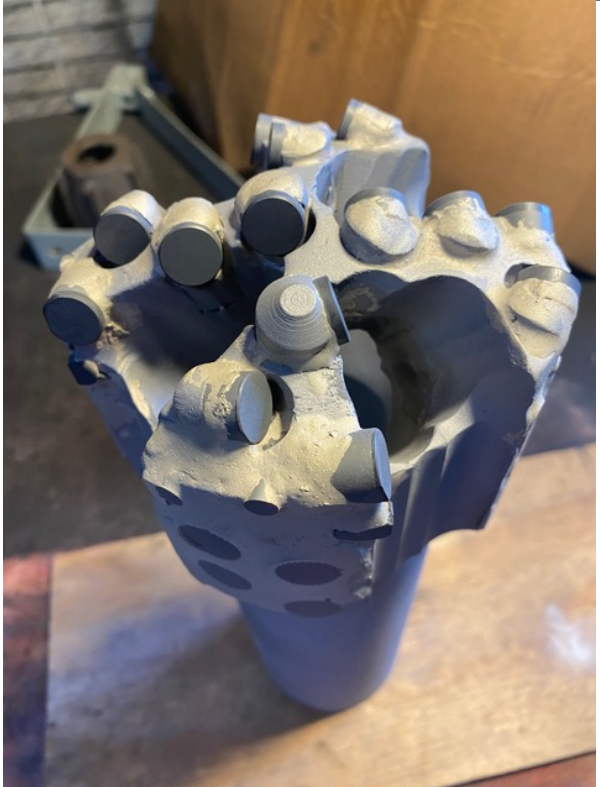
After refit shown at left
