Case History: Hughes Specialty Tools for Apache Corp / Western Oklahoma ~ March, 2012

Target: Partial liner hanger setting tool (Q-125 hardened steel) and stuck aluminum plug...all with remnants of Kutrite and Diamond Mills on top

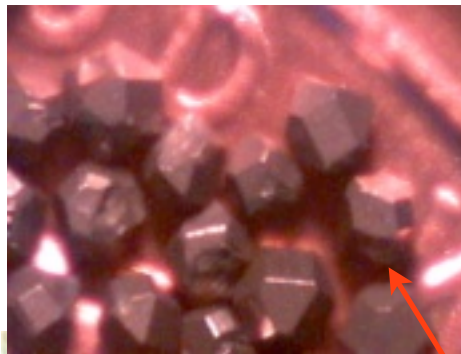
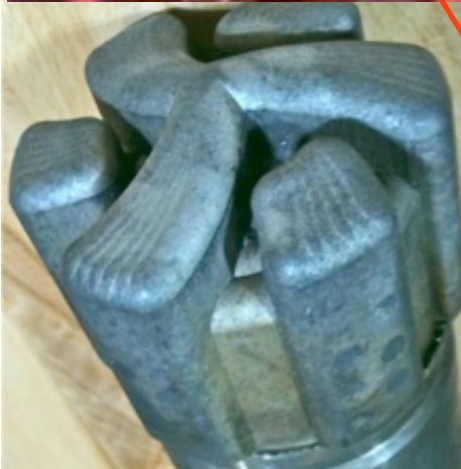
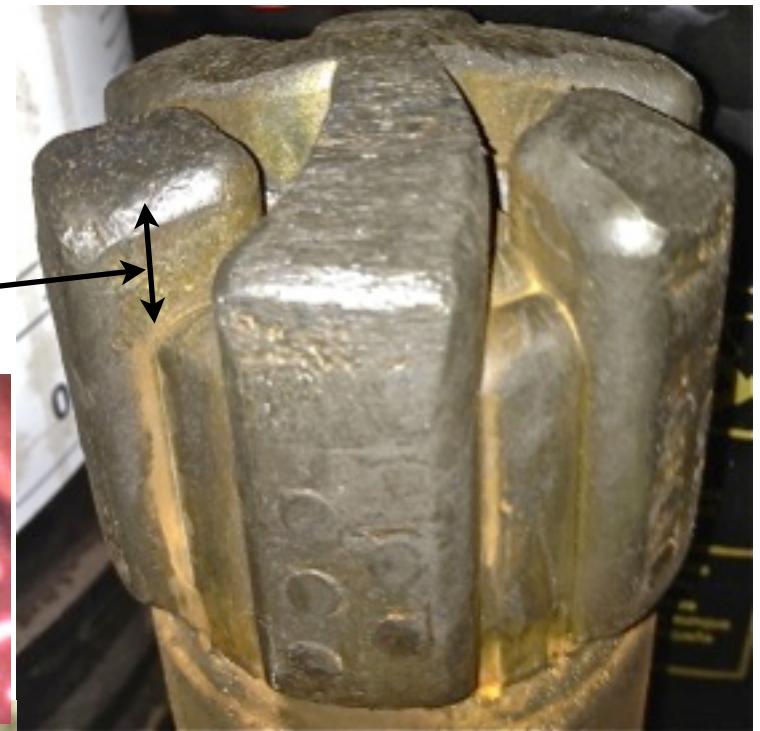
Results: Cut all 8" of Q-125 and enough of the Aluminum plug so that it released...mill wear about 15-20%

Remaining Impreg

MX style mills and XDS style shoes have a 30 to 60 mesh diamond grit that is blended with and infiltrated into the mill blades as much as 3/4". The grit diamonds do work in a grinding action that has cut targets as hard as sintered carbide. As each individual diamond is dulled by friction or impact it is sloughed out of the matrix that wears away to expose fresh diamond. This is repeated until the blade thickness is used up.
