## Case History: Viceroy Petroleum. LLC

**Target:** Carbide Mill stuck on top of fish with loose carbide packed in annulus on top of the mill.

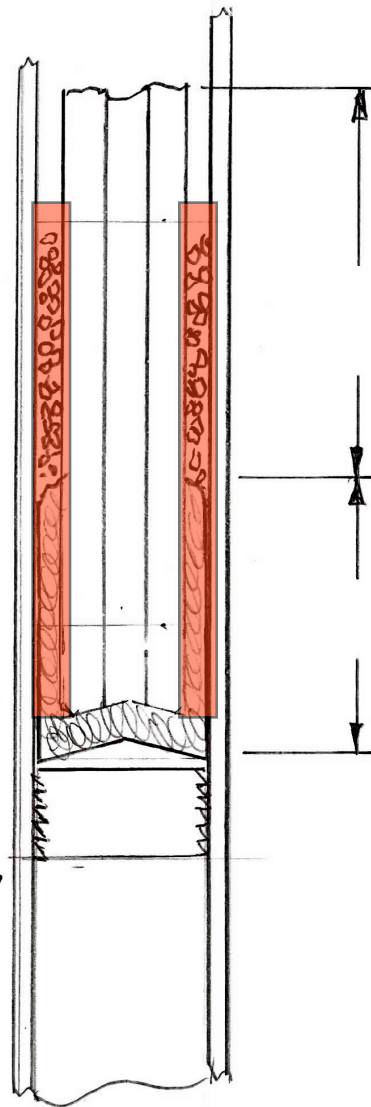
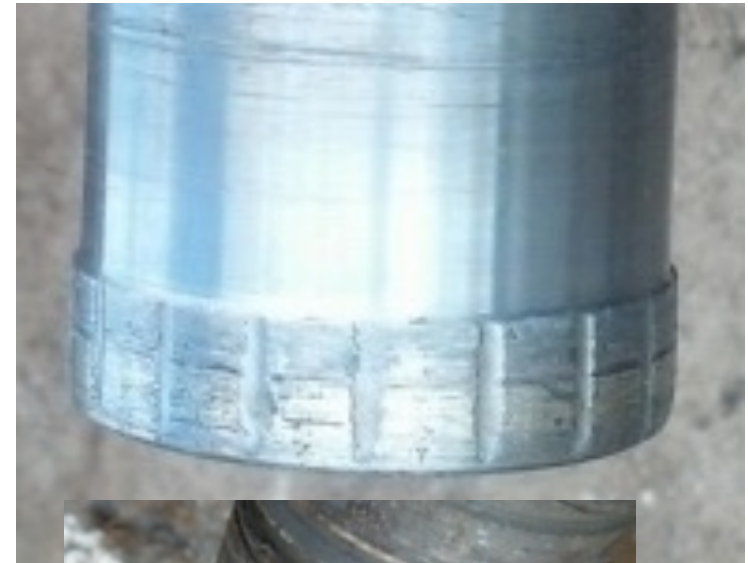
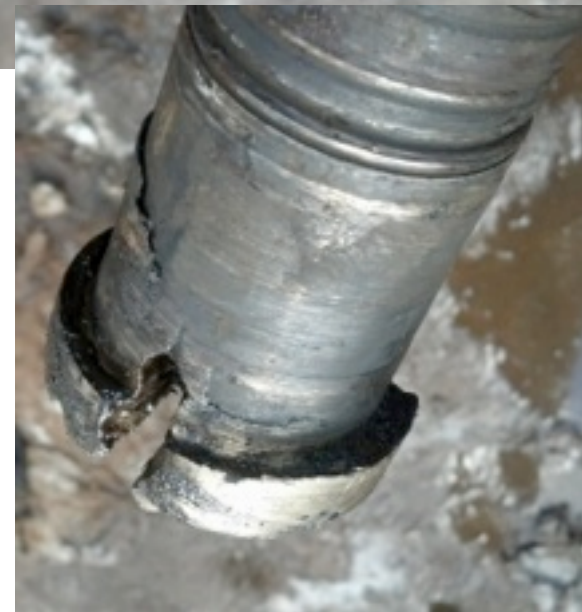
**Result:** Total 14 hours cut all of loose WC and about 6" of mill carbide gage and released.

Wear on shoe about 20%

**Shoe Run:** 2.850" x 2.250" SXDS thinwall diamond shoe run on jointed pipe with 1000 to 1500 # WOB and 120-140 RPM.
